***250,000 GALLON 8TH STREET
ELEVATED WATER TANK
KILL DEVIL HILLS, NORTH CAROLINA***

**SOUTHERN CORROSION INC.
INSPECTION REPORT**

Inspection Date: May 9, 2017

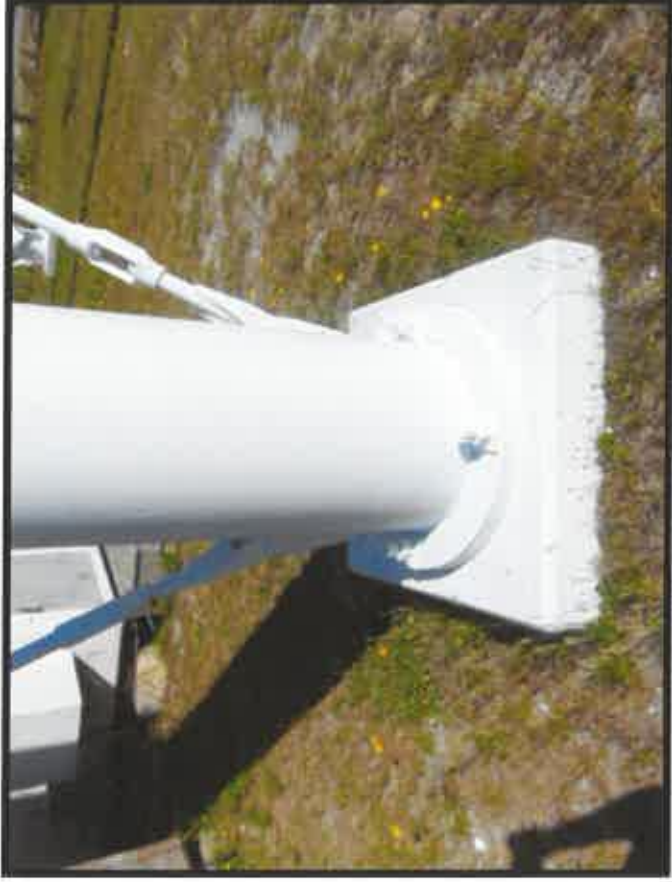
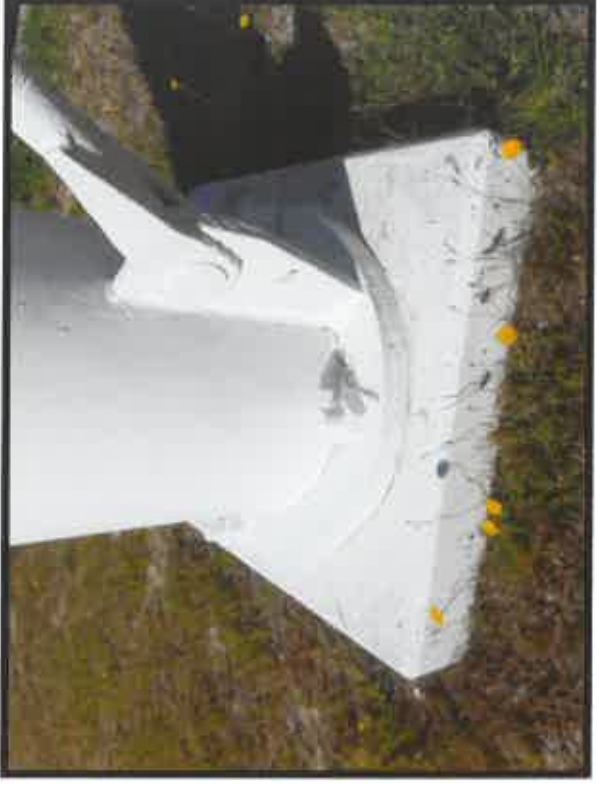
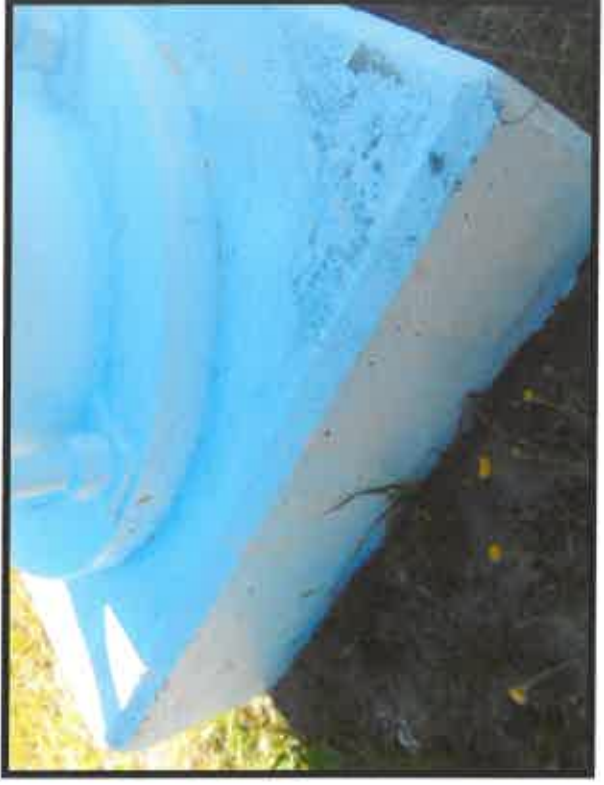
The concrete foundations are in good condition. There is no evidence of cracking or spalling. The tops and sides of the foundations are painted white.

View of the painted concrete foundations and base plates.

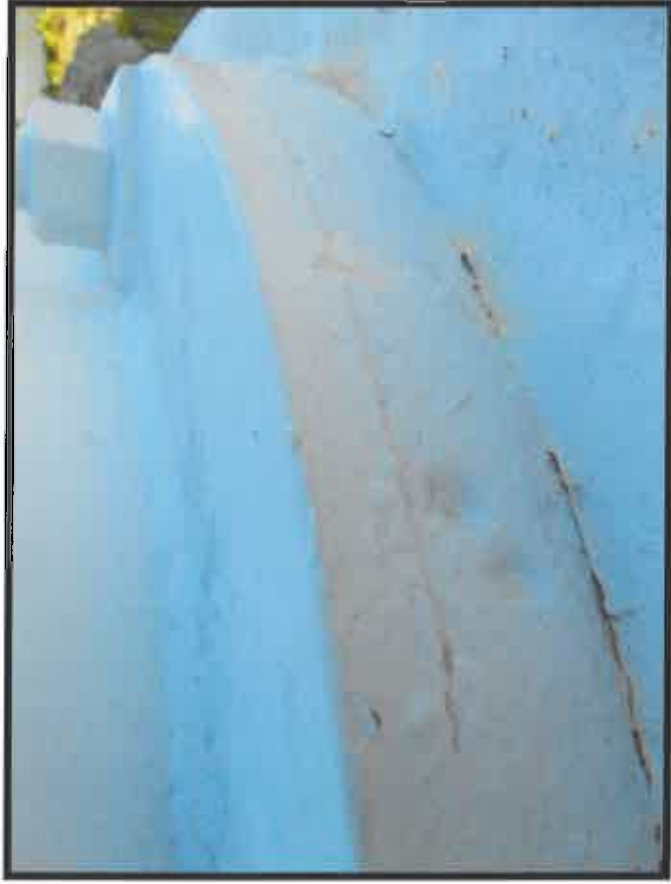
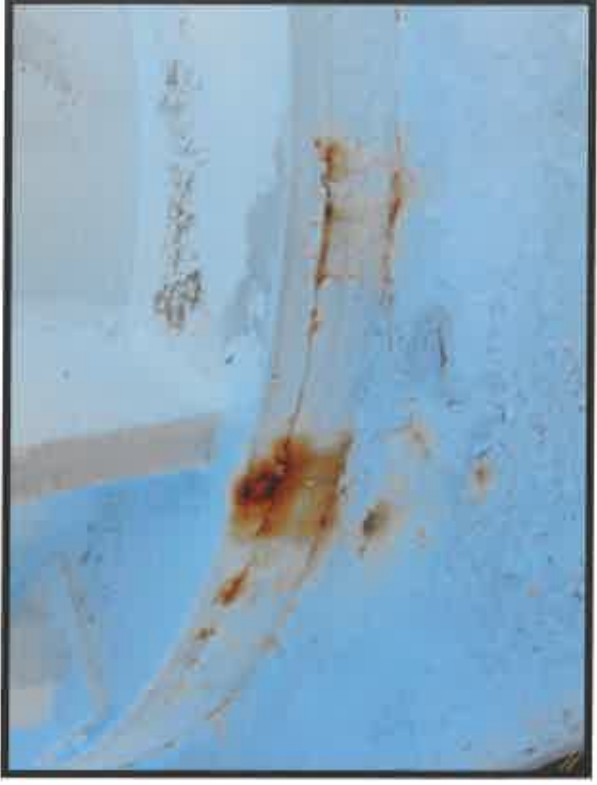
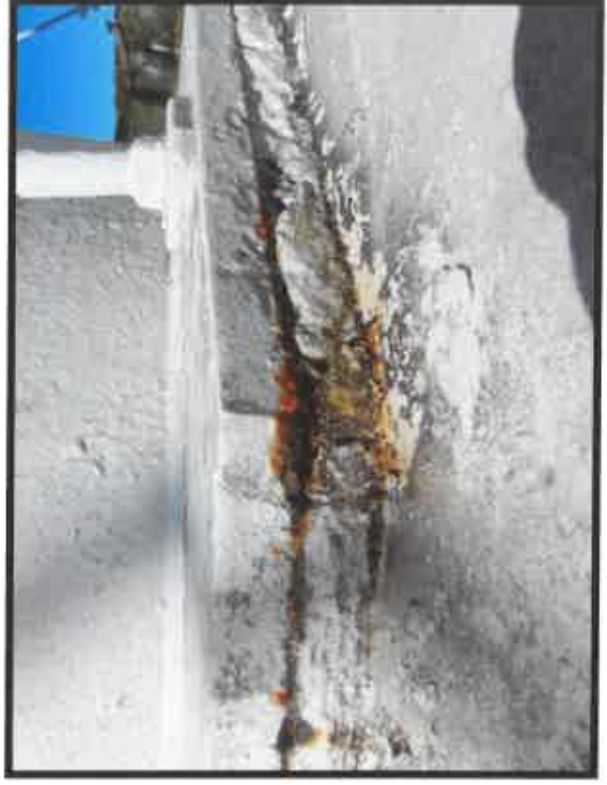
The base plates are in good condition. There is surface rust occurring on less than 5% of base plate surfaces.

View of the base plates and grout.

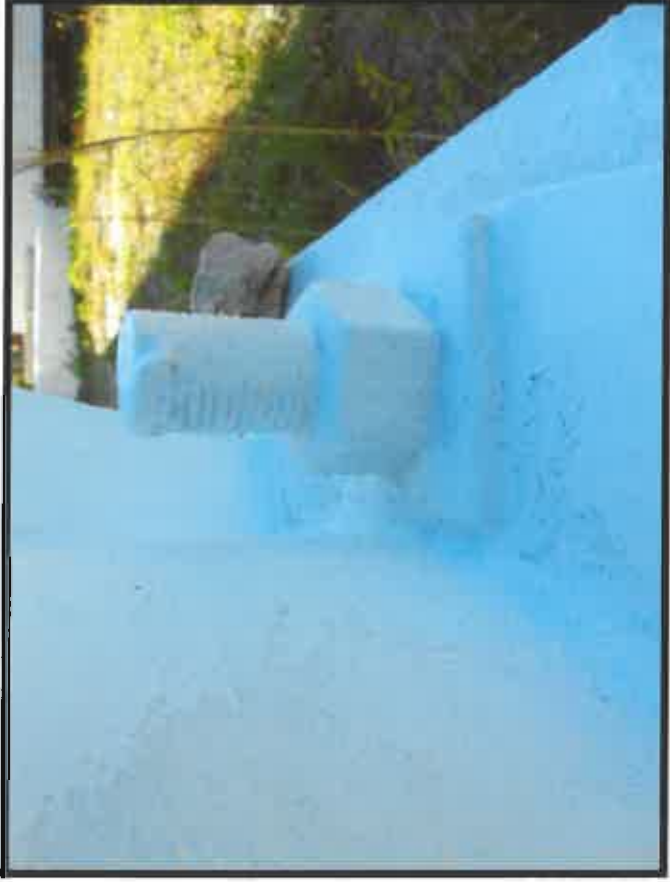
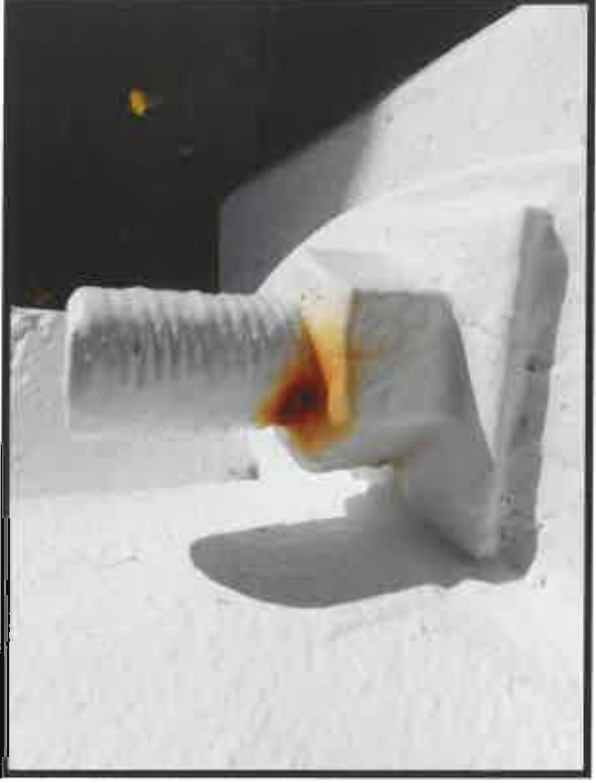
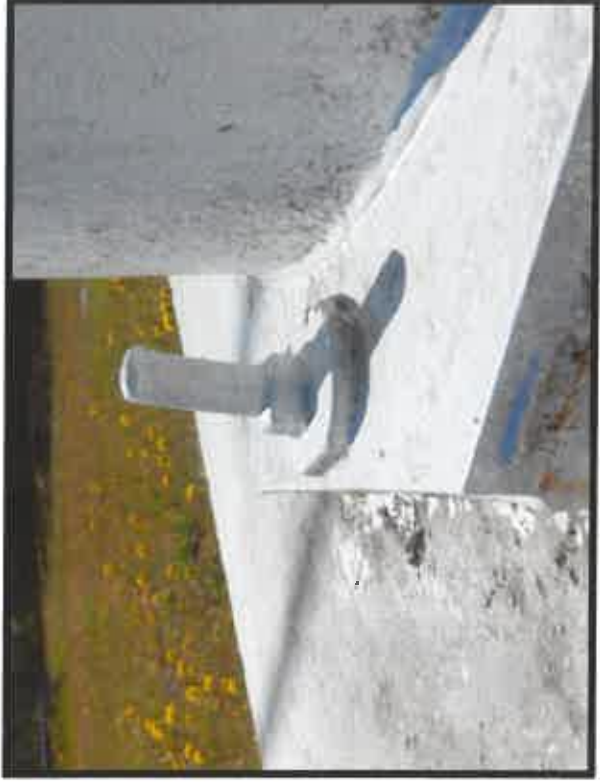
Each column leg is equipped with four 1 $\frac{3}{4}$ -inch anchor bolts. There is corrosion present on less than 5% of anchor nut and bolt surfaces. The riser pipe is equipped with four 1-inch anchor bolts that are in good condition. One of these bolts appears to be bent inward toward the riser pipe.

View of the anchor bolts on the column legs and riser column.

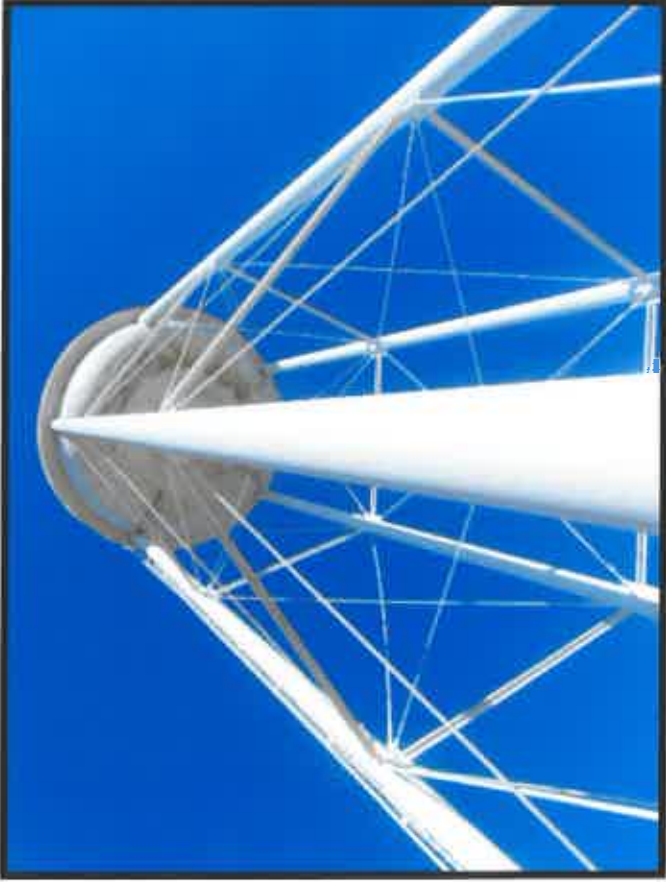
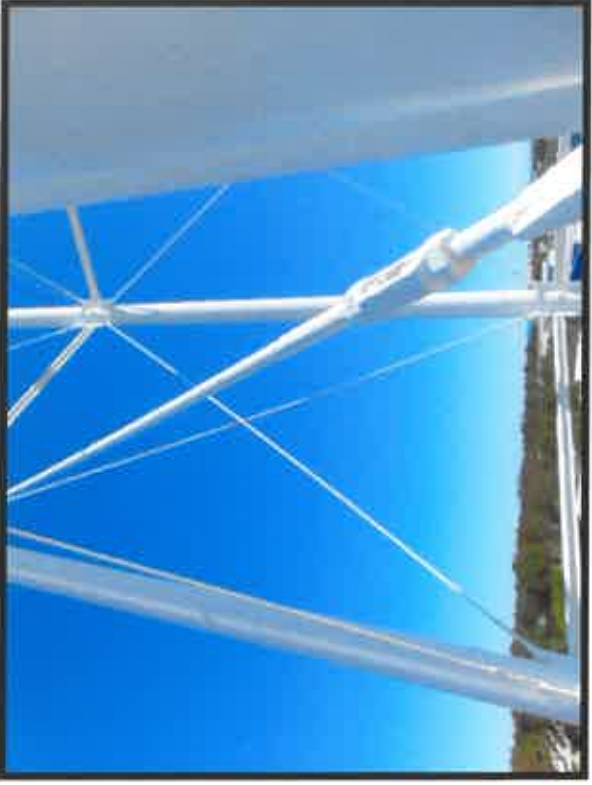
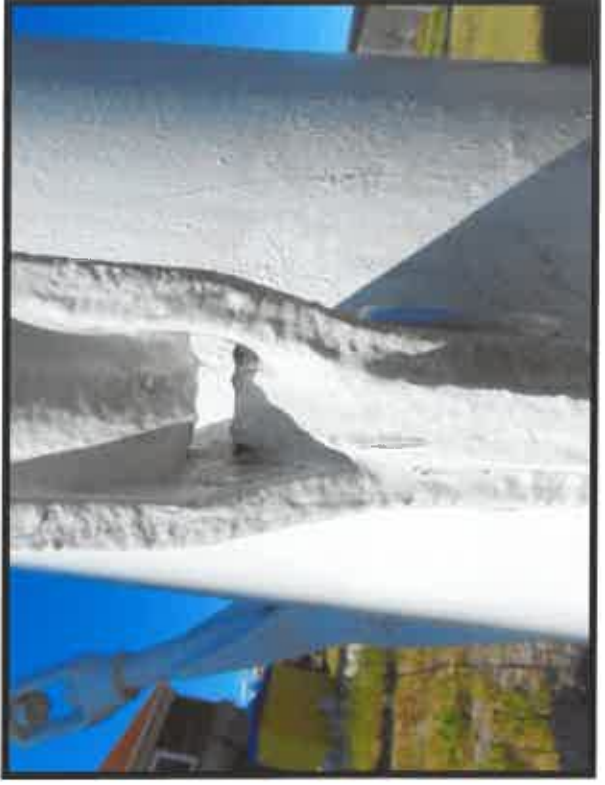
The coatings of the column legs appear to be in good condition with less than 1% observed corrosion.

The tank is not missing any rods. The rods are securely attached to the column legs. Surface corrosion is visible on approximately 5% of the rods, struts, and turnbuckles.

View of the column legs, wind rods, and turnbuckles.

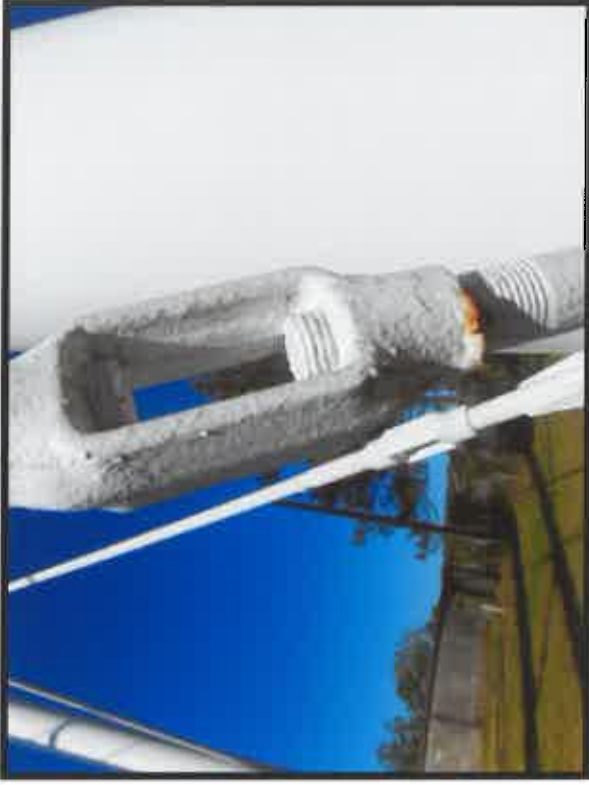
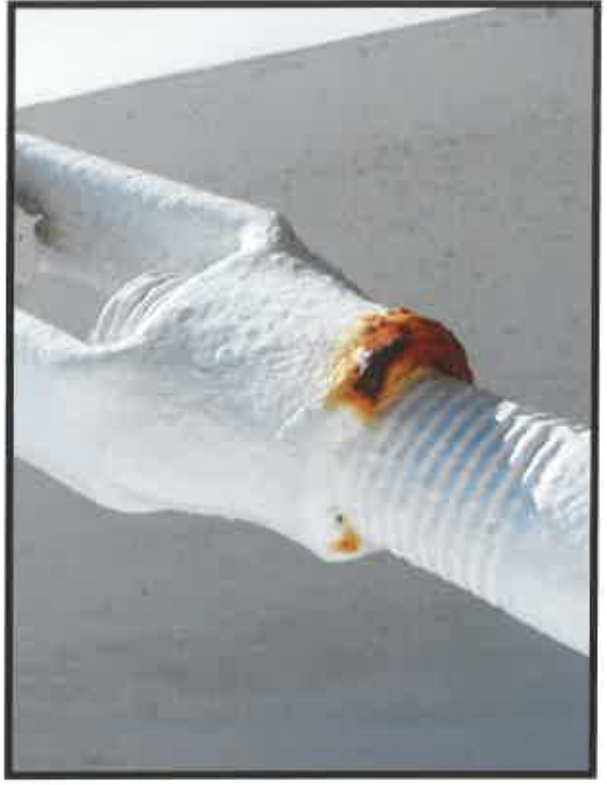
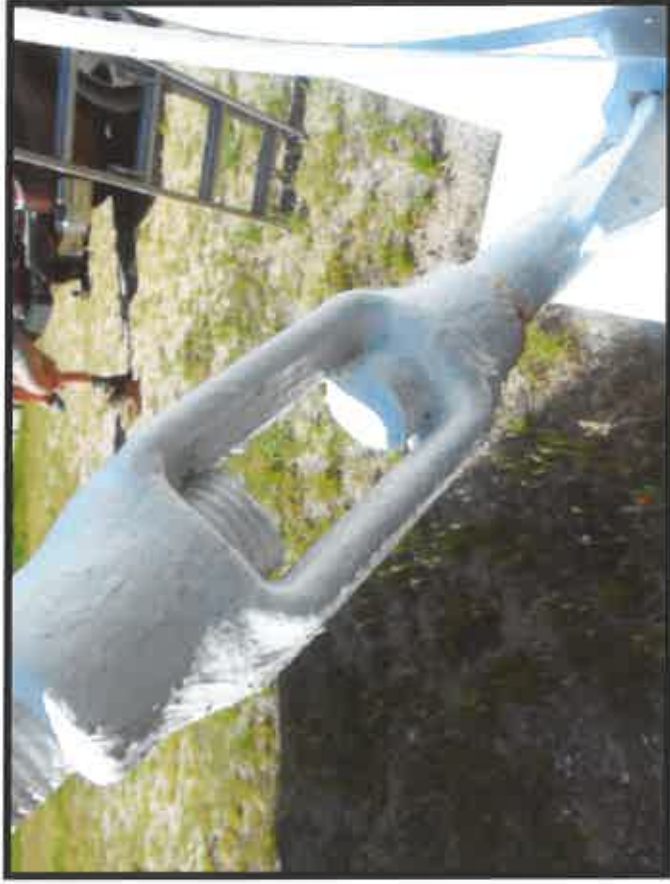
View of the turnbuckles.

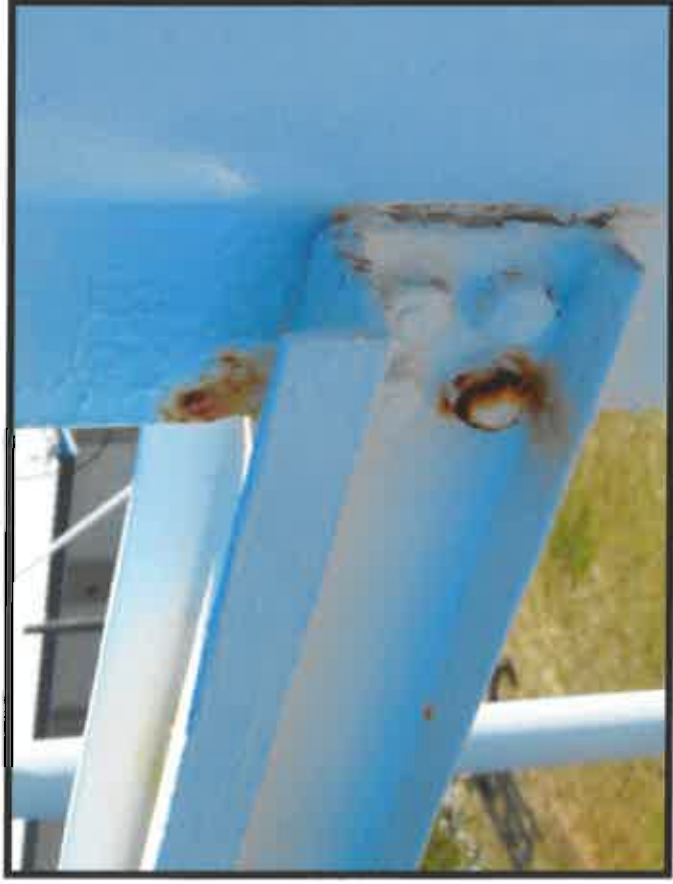
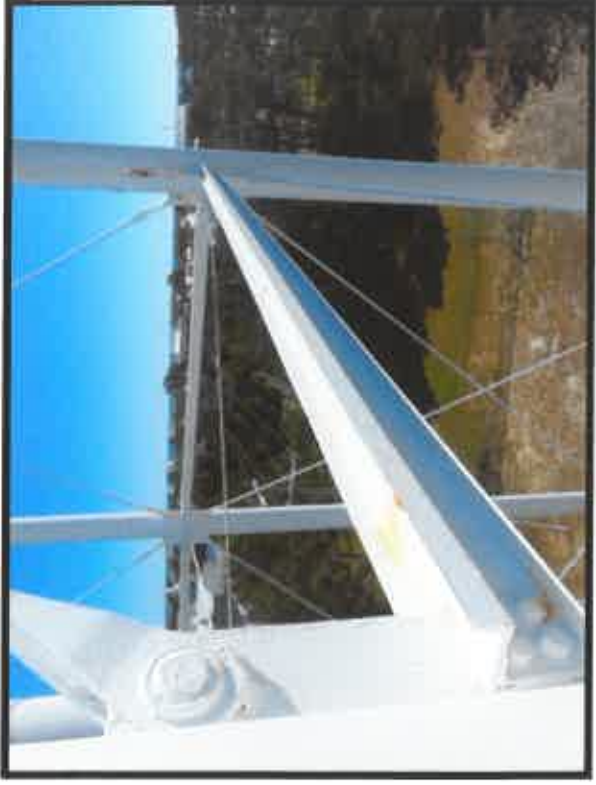
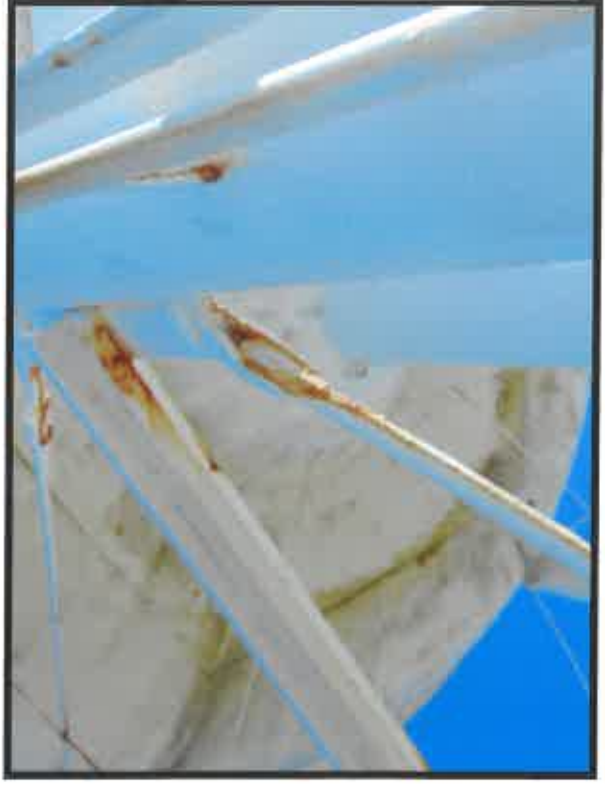
View of the struts and wind rods.

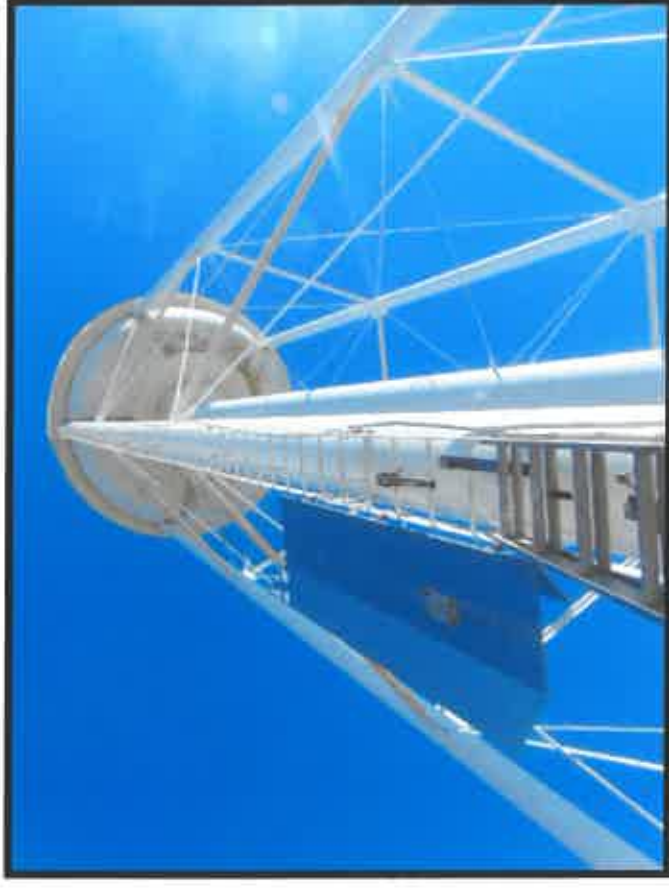
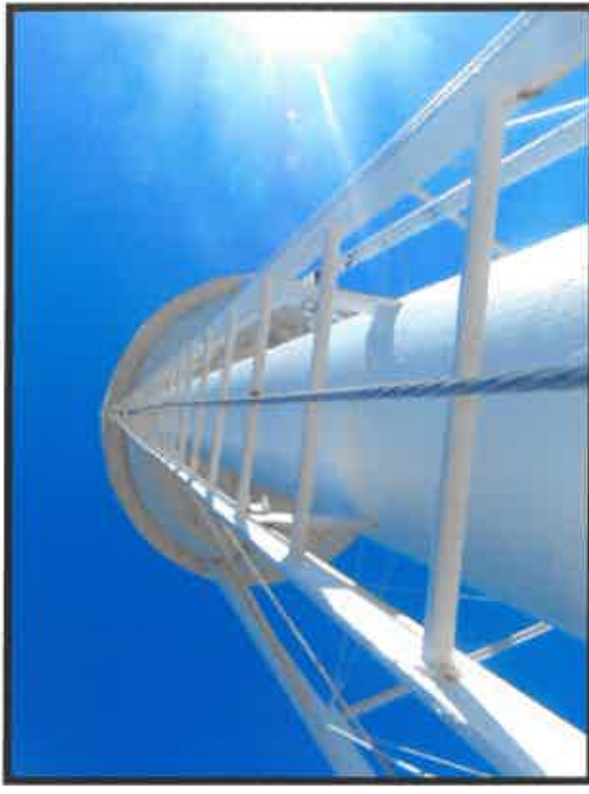
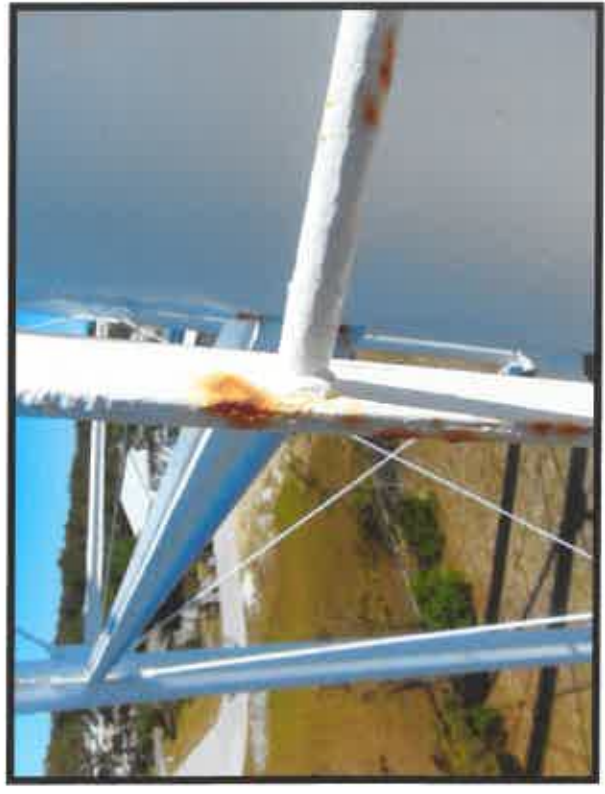
The tower ladder is attached to the column leg via welded stand off supports. The ladder is in good condition with less than 5% surface corrosion. It is equipped with a cable-style fall protection system as required by OSHA fall prevention regulations. The hardware components of the fall protection system are visibly corroded and there are multiple missing bolts and/or nuts. The rungs are round and not anti-slip. There are no missing, bent, or otherwise deteriorating rungs. An anti-climb prevention device (ladder guard) is attached to the lower portion of the ladder.

View of the ladder.

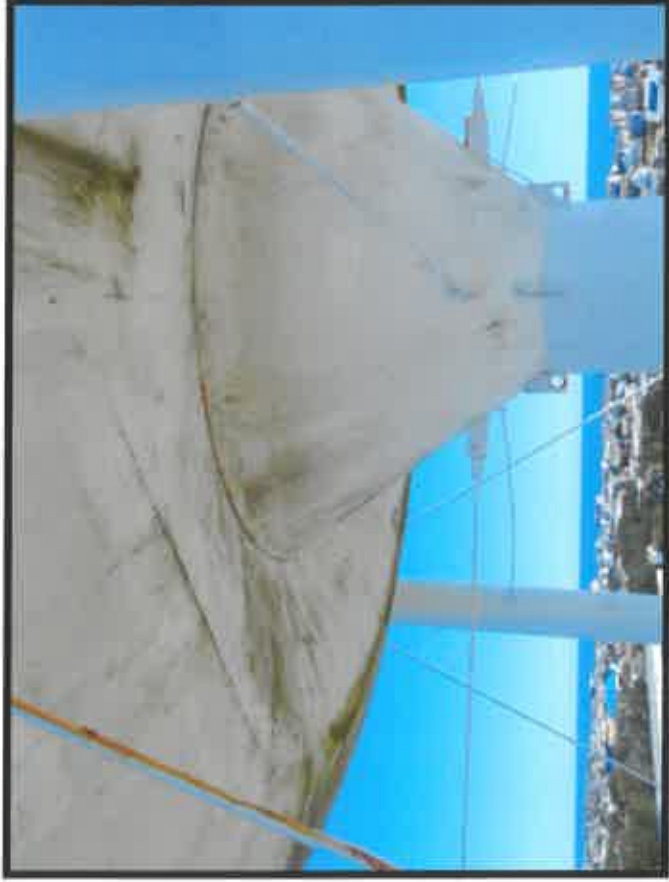
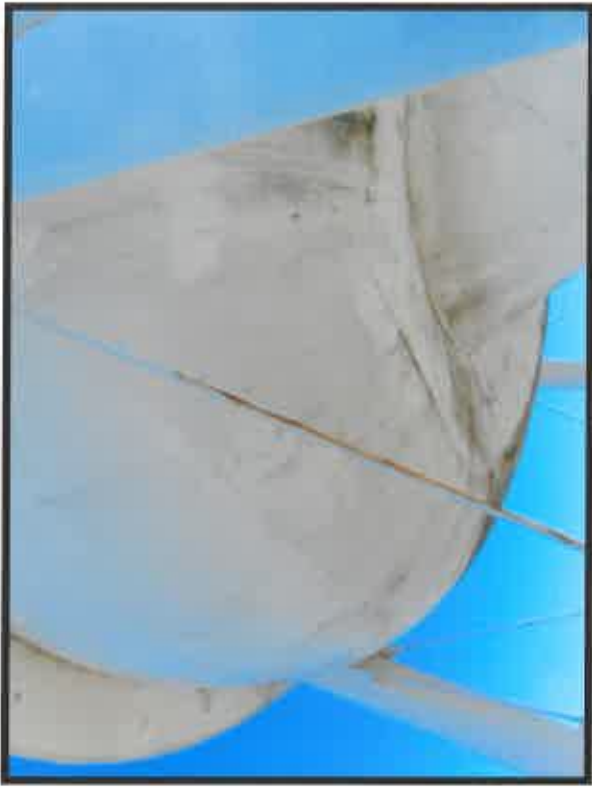
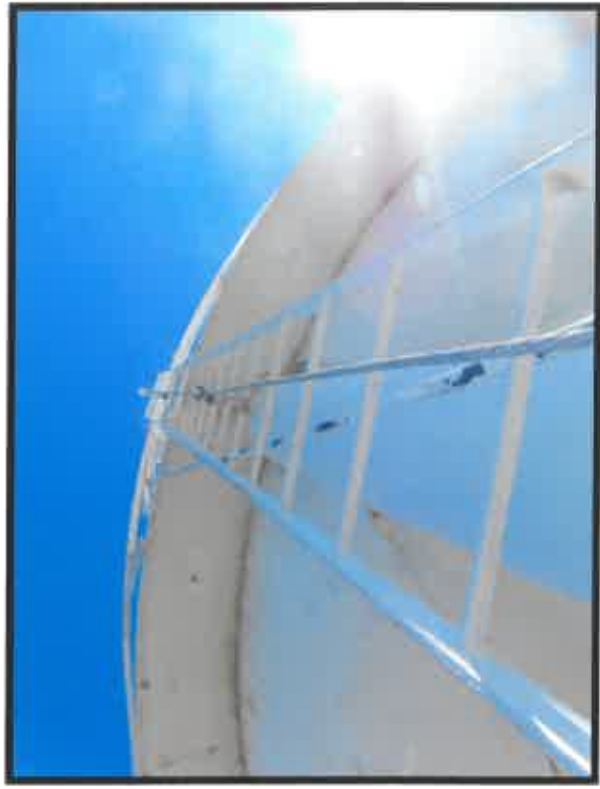
The tank bowl is in good condition. There were no leaks evident at the time of inspection. The coatings appear to be in fair condition with no observed corrosion present. Mildew is visible throughout the surface of the tank bowl.

The underside of the catwalk appears to be in good condition with observed corrosion on less than 1% of surfaces.

View of the tank bowl and underside of the catwalk.

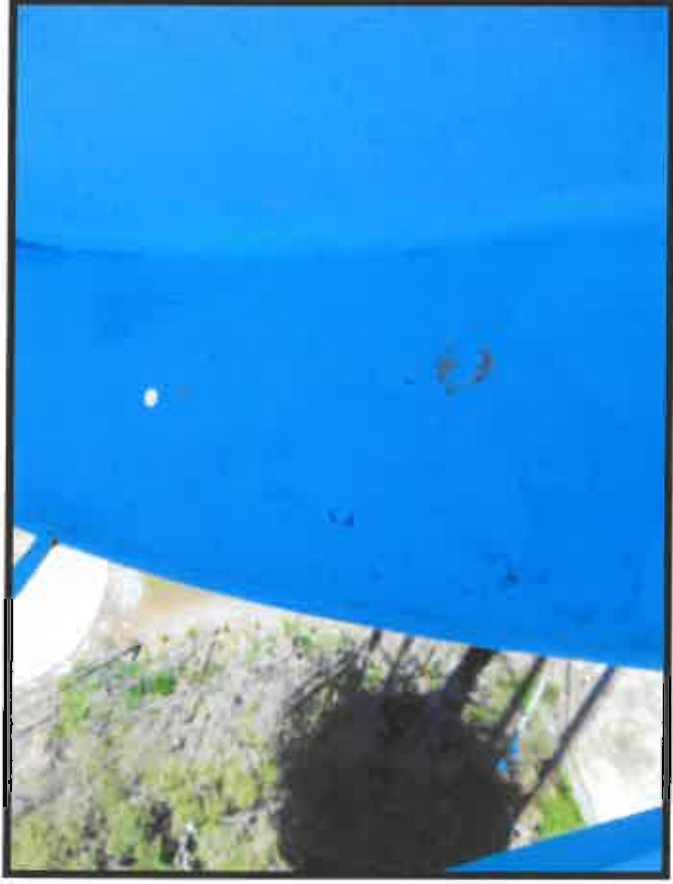
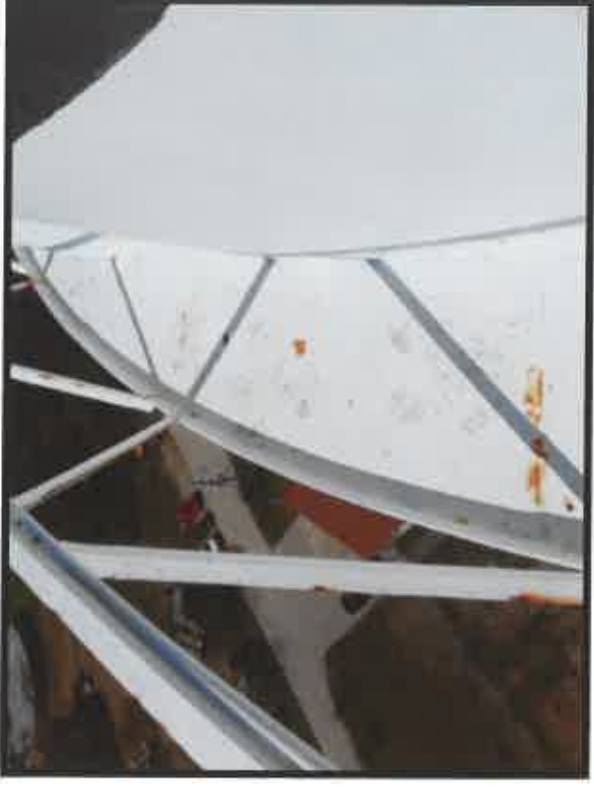
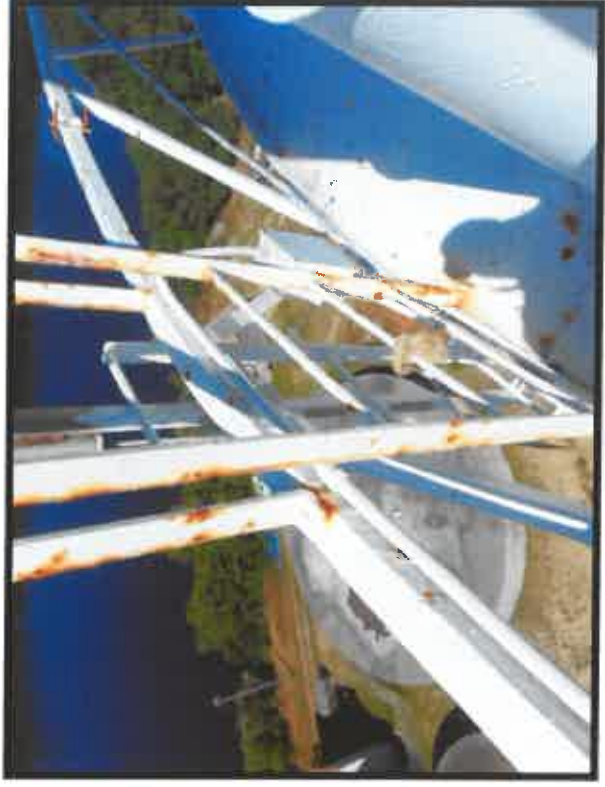
The catwalk balcony has a toe plate, supports, and hand rail that are welded to the catwalk floor. The hand rail measures 42 inches in height as required by OSHA safety regulations. The hand rail, its supports, and toe plate are in good condition with observed corrosion on less than 5% of surfaces.

The catwalk floor is in good condition with observed corrosion on less than 1% of surfaces. The catwalk floor is equipped with weep holes to prevent pooling. There is mildew present in various areas throughout the catwalk.

View of the catwalk, toe plate, hand rail, and ladder.

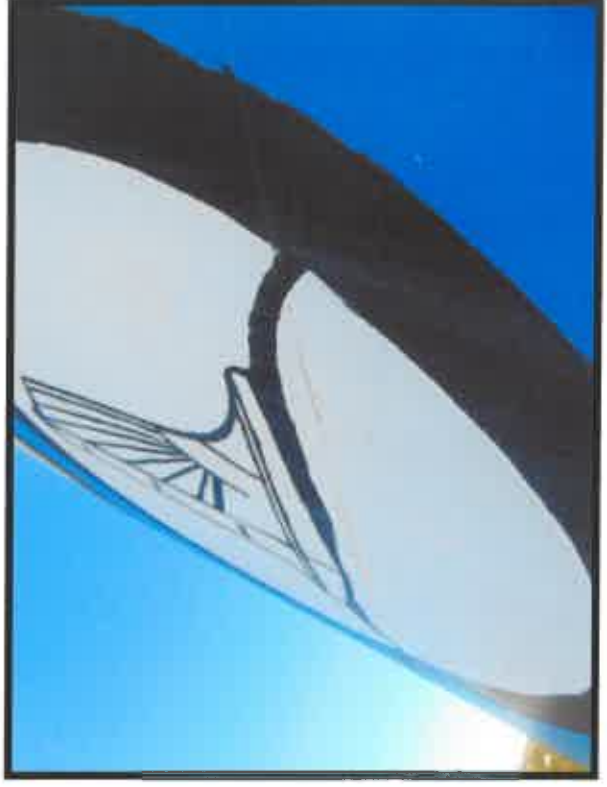
There is a steel structure (non-structural) located on the exterior shell wall that shows significant signs of corrosion (steel loss). This structure measures approximately 2 feet wide by 6 inches tall. This structure could potentially be used to create space between conduit/electrical wires and the tank shell wall (there are no such conduit/wires on this tank).

The exterior shell wall appears to be in fair condition with no leaks present. The tank logo is featured on two sides of the tank and reads *KILL DEVIL HILLS*. The logo is cast in white letters upon a blue background. Both the letters as well as the blue background are framed with a black outline. The logo measures 40 feet in width and 6 feet in height. Each logo is complete with a mural of a sun dial.

View of the shell wall.

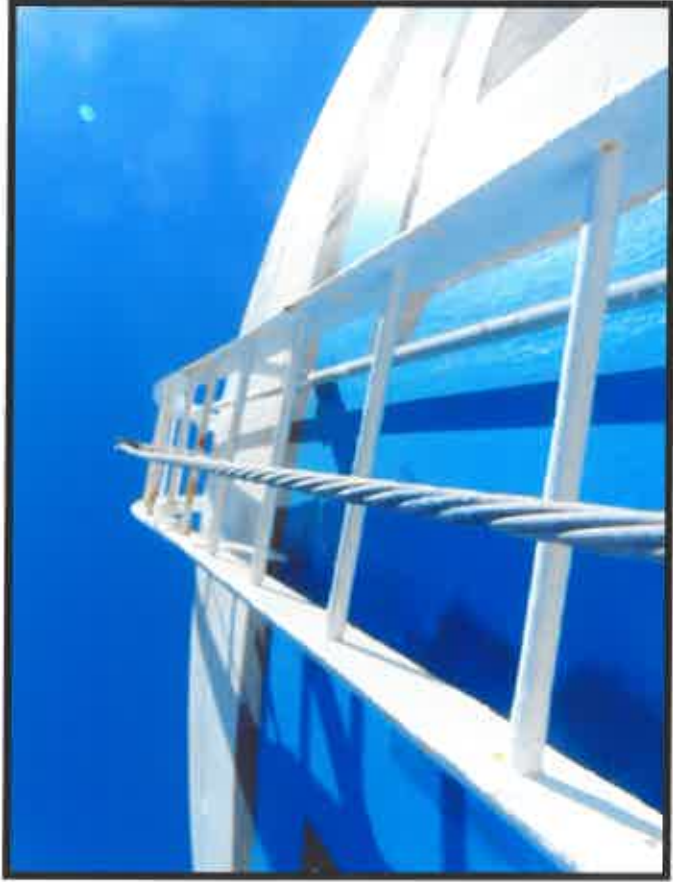
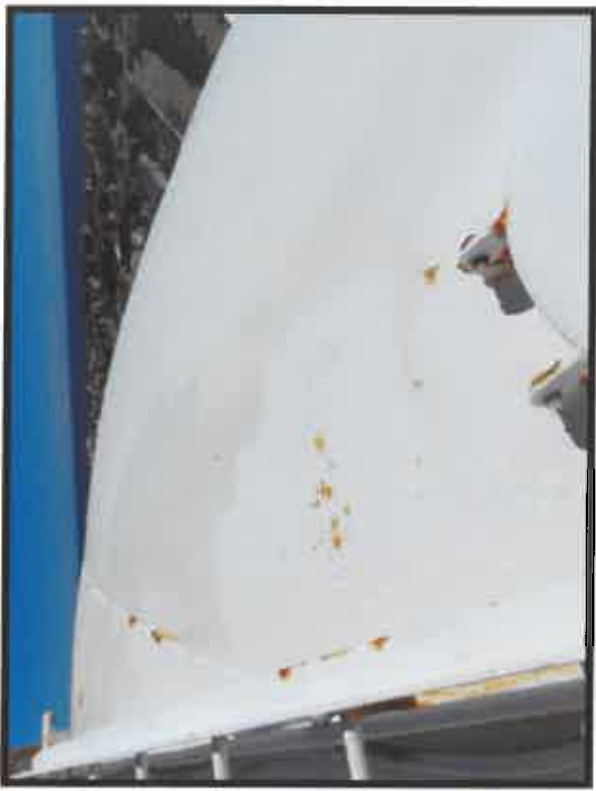
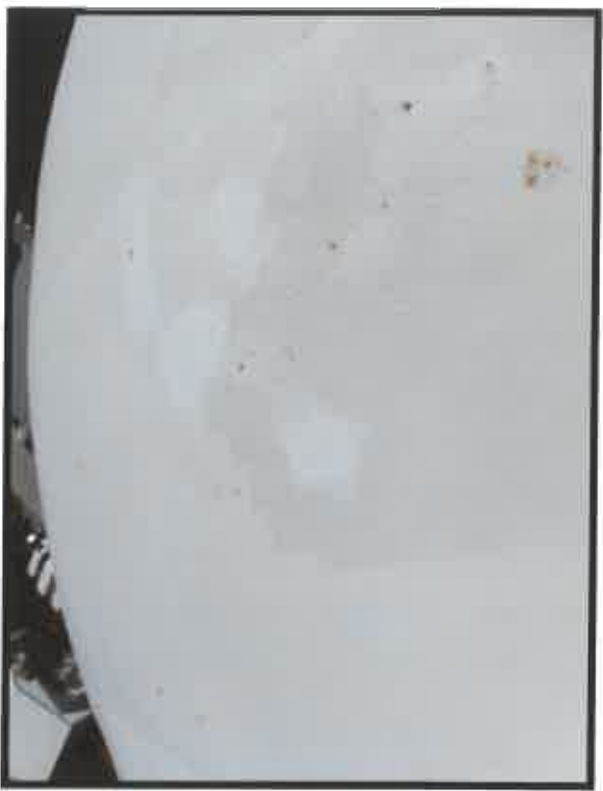
The tank features a ladder that provides access from the catwalk to the roof. The shell ladder is attached to the shell wall and tank roof by welded stand off supports. The shell ladder is equipped with a cable-style fall prevention system as required by OSHA fall prevention regulations. The ladder is in good condition with no missing, bent, or deteriorated rungs or railings. There is observed surface corrosion on approximately 10% of ladder surfaces.

The tank roof is in good condition with light surface rust visible on less than 5% of surfaces. The tank roof is equipped with an access hatch that is round and in good condition. The hinges and hasp are functioning properly, but are visibly corroding. The access hatch has a pin (attached to a chain, which is welded to the lid) to keep the lid closed. No lock was present at the time of inspection, but per customer request, a Southern Corrosion lock was installed upon completion of the inspection. Observed corrosion is prevalent on the access hatch interior and lip.

View of the roof ladder, and roof.

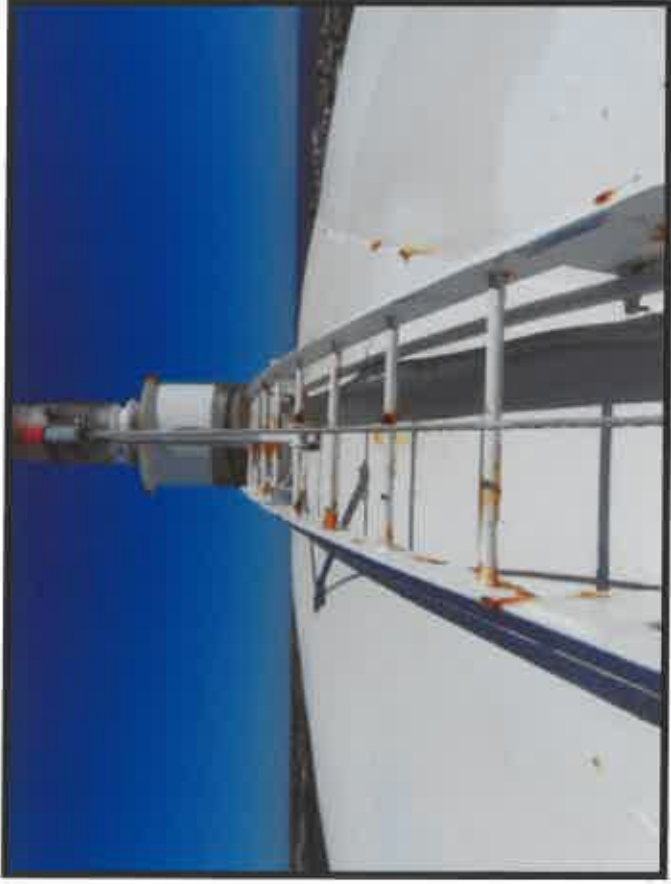
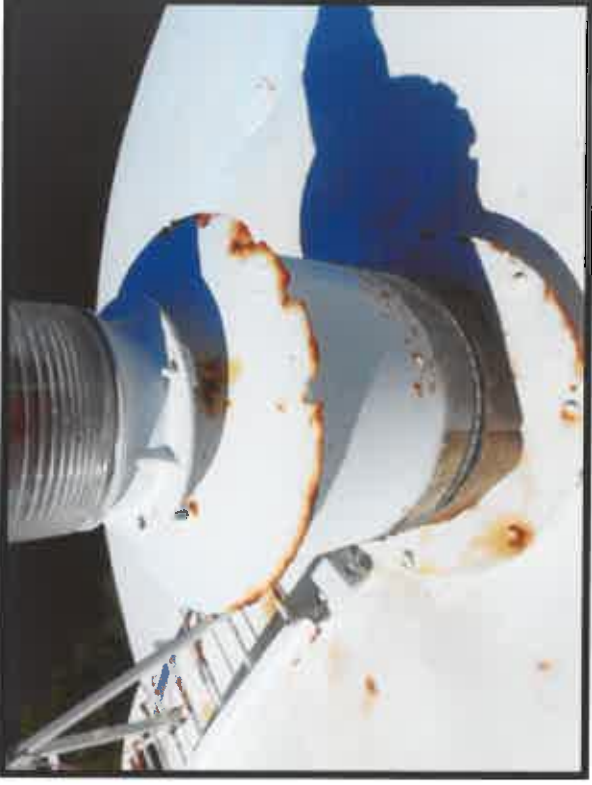
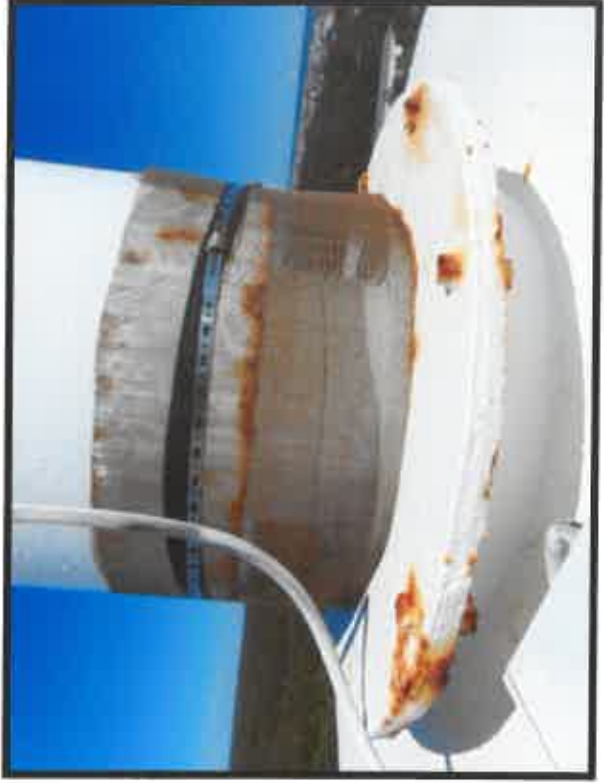
The roof vent is in good condition, with observed corrosion present on approximately 20% of surfaces.

View of the roof ladder and vent.

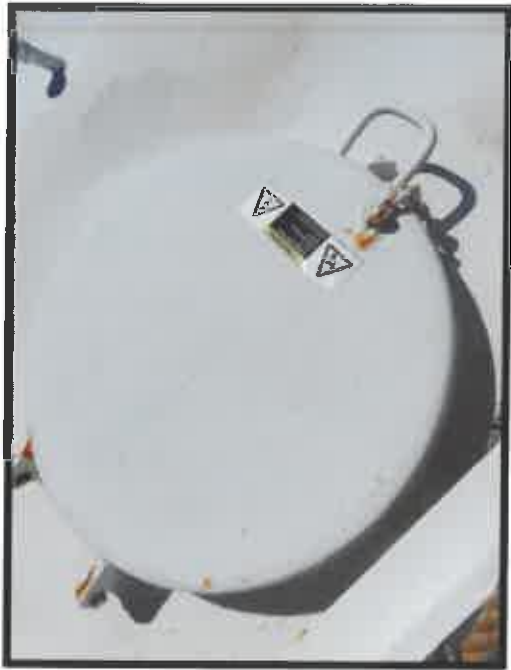
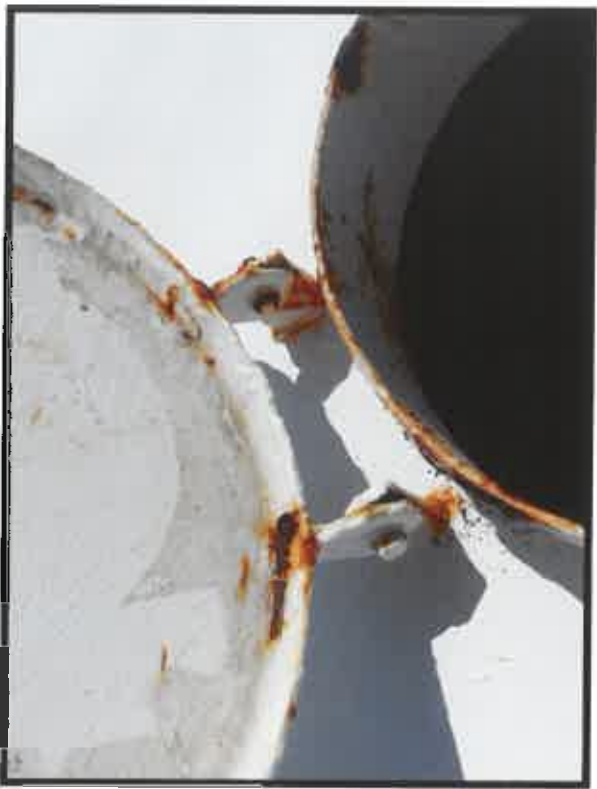
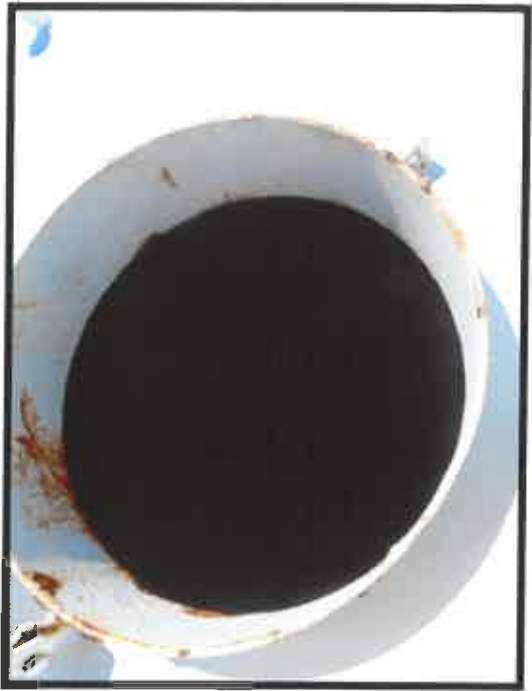
View of the access hatch, hinges, and interior lip of access hatch.

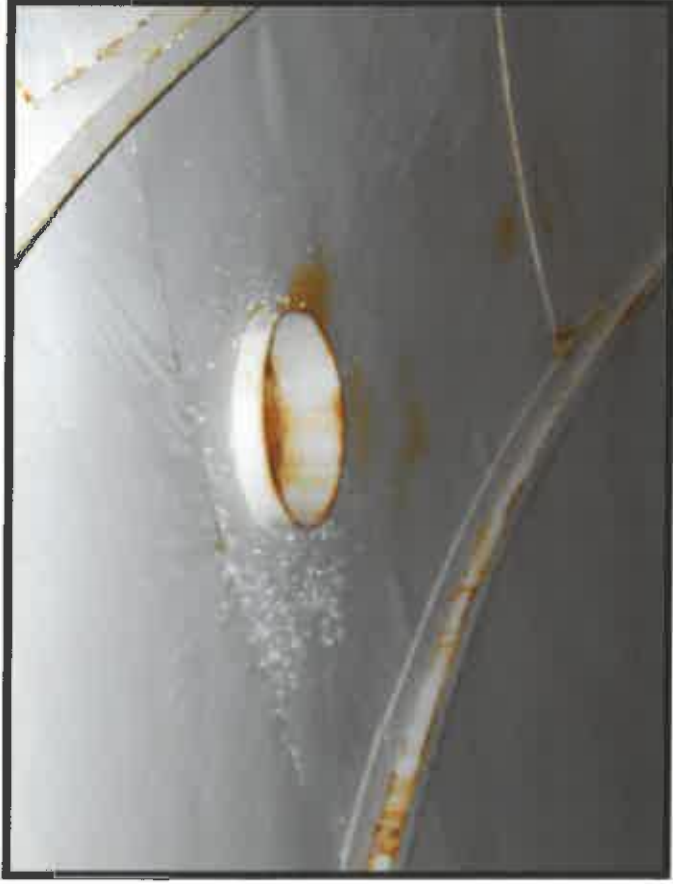
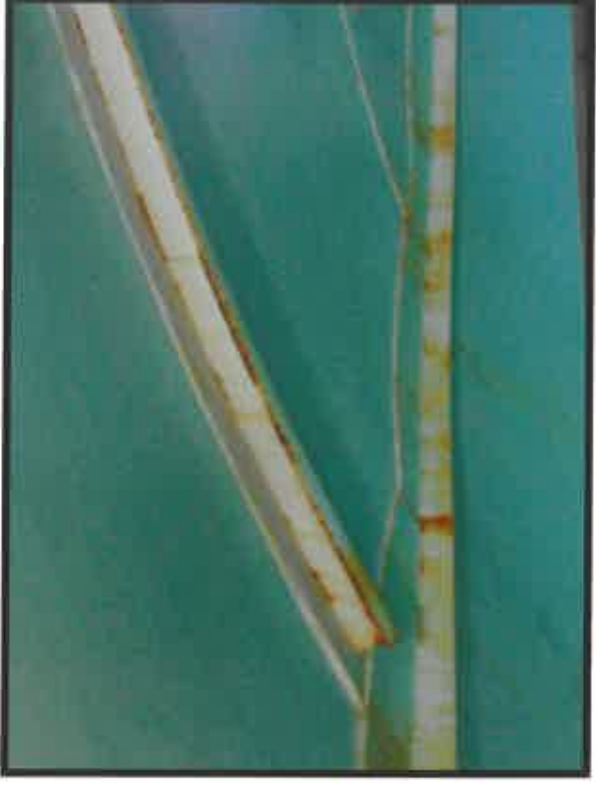
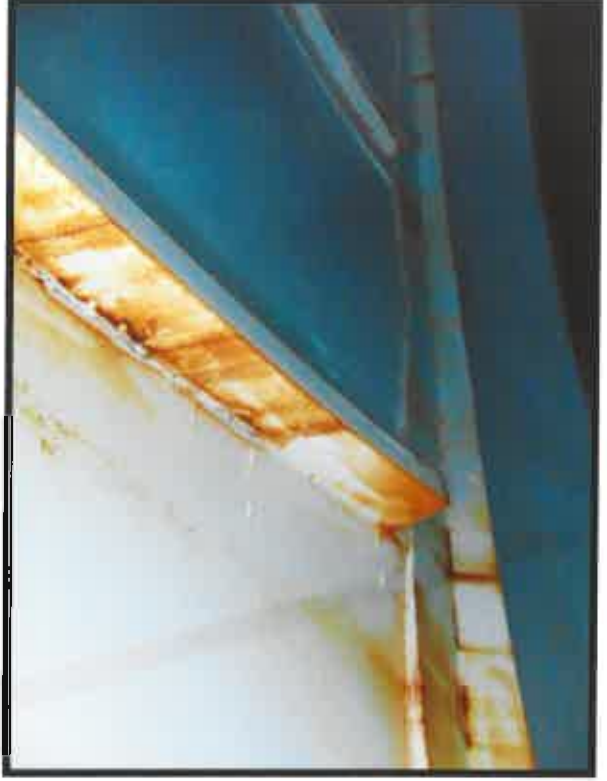
The roof interior appears to be in good condition with approximately 10% visible surface corrosion.

View of the interior roof.

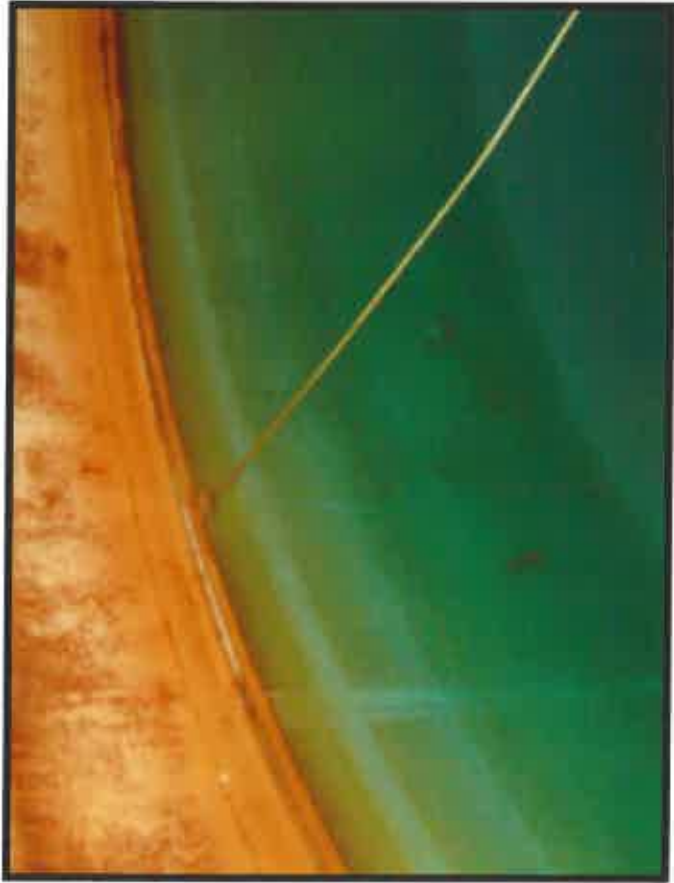
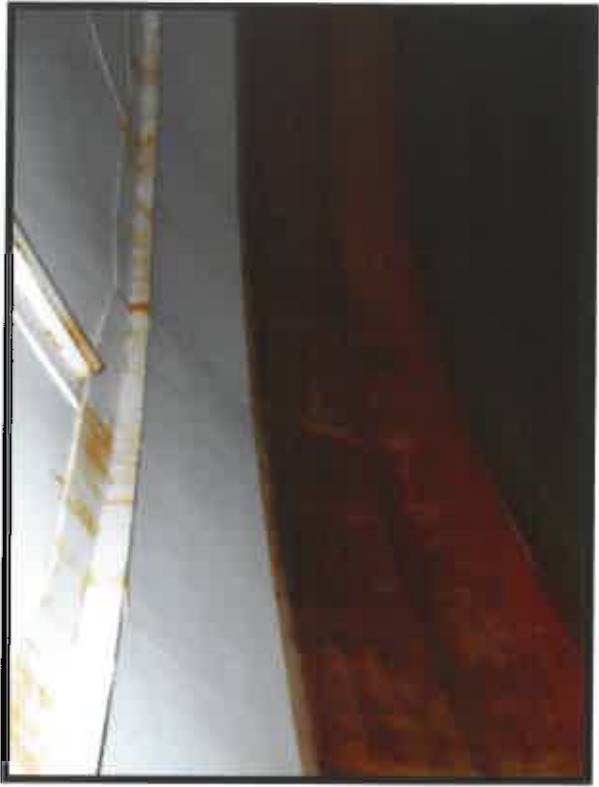
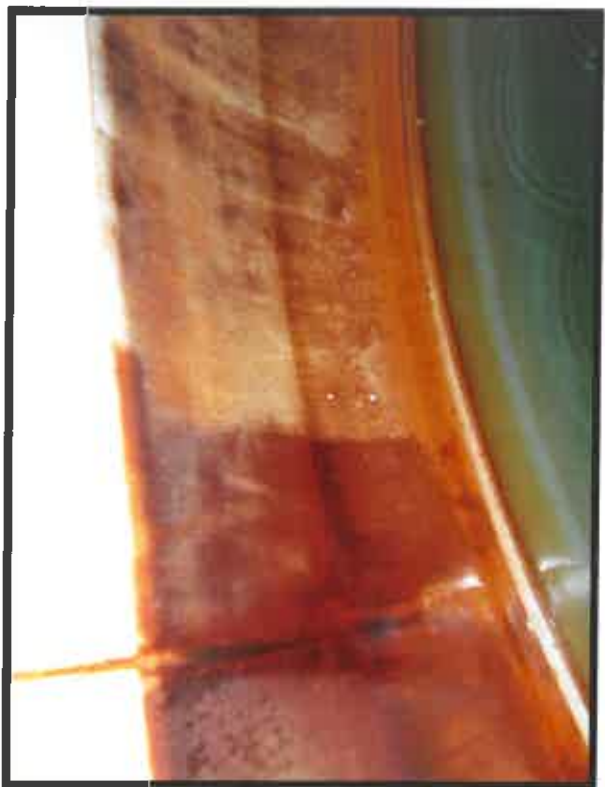
The observed interior shell wall has apparent staining and discoloration, which is generally caused by the elements in the water. The ROV inspection revealed buildup of sediment in several areas along the interior shell wall. There is apparent surface corrosion along the painter's ring.

View of the interior shell wall.
