***250,000 GALLON 8TH STREET
ELEVATED WATER TANK
KILL DEVIL HILLS, NORTH CAROLINA***

**SOUTHERN CORROSION INC.
INSPECTION REPORT**

Inspection Date: May 9, 2017

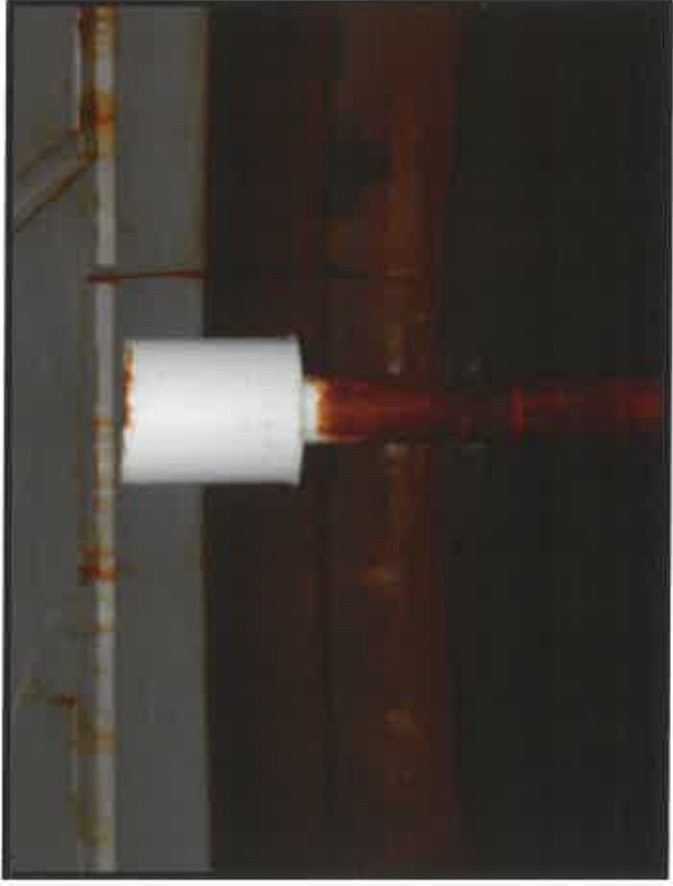
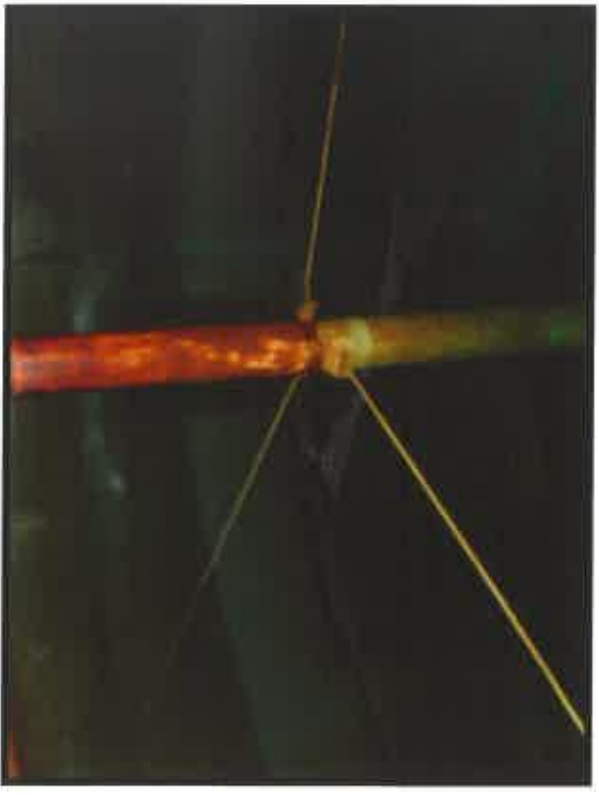
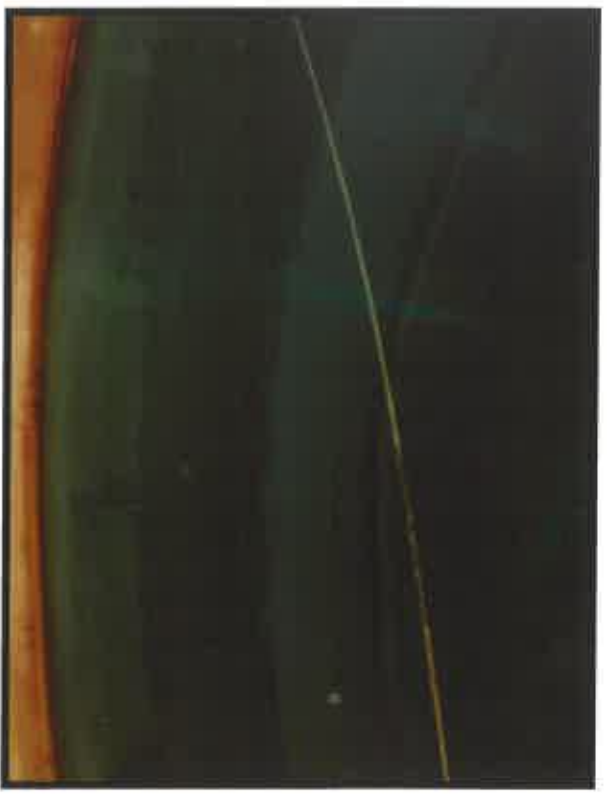
The tank interior is in good condition with observed staining consistent with elements in the water. The ROV inspection revealed surface corrosion on the fill pipe/overflow support rods as well as along the interior shell wall.

View of the overflow pipe and support rods.
